PHOTOGRAPHIC SURVEY OF THE LDEF MISSION

NASA Special Publication 531

Robert L. O'Neal

National Aeronautics and
Space Administration

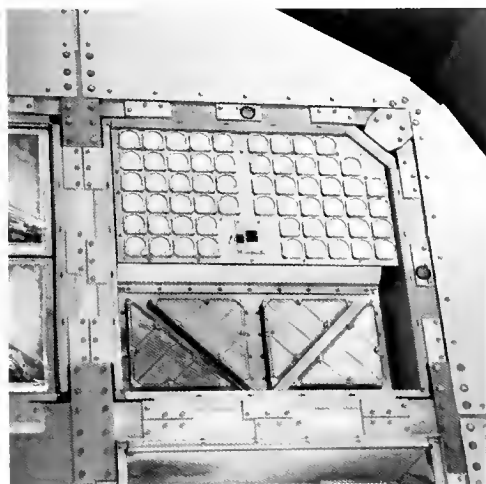
Figure 609
Photo No.: S32(S)-284
Dup. Neg. No.: L92-21191
LISAR NO.: EL-1994-00073
Photo Credit: JSC
Photo Date: 1/22/90
Location: Shuttle Cargo Bay at Dryden
Subject: Postflight Survey of Tray H11

Figure 609 (Postflight). This postlanding photograph was taken from the cargo bay access hatch of the orbiter during postlanding operations at the Dryden Flight Research Center. Note the discolorations on the structure of the LDEF, tray flanges, and tray clamp white dots and the variation of discoloration with proximity to the thermal panel vents. The colors in the mirrorlike surface of the detectors are a reflection of the cargo bay liner of the orbiter.

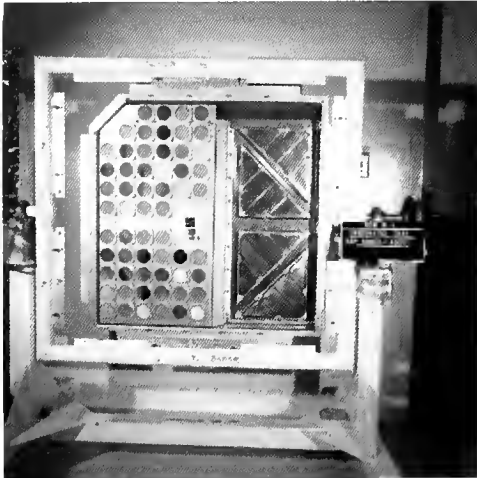
Figure 610
Photo No.: KSC-390C-2065.07
Dup. Neg. No.: L91-15678
LISAR NO.: EL-1994-00297
Photo Credit: KSC
Photo Date: 3/19/90
Location: KSC SAEF II
Subject: Postflight Survey of Tray H11

Figure 610 (Postflight). Both experiments appear intact. The colors in the mirrorlike surface of the detectors are reflections of the surrounding area. A dark spot on a detector in the third row from the top in the in-flight photograph was not found in a postflight inspection.

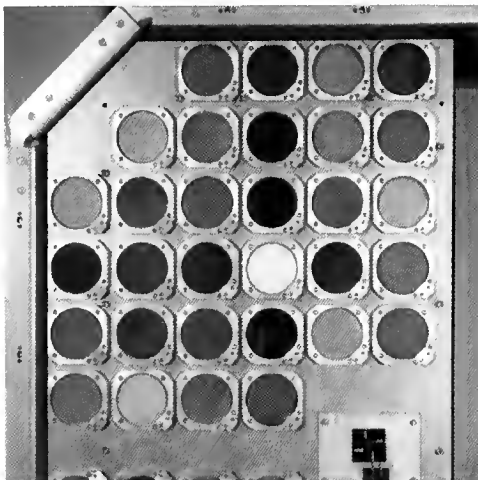
Figure 611
Photo No.: KSC-390C-2065.08
Dup. Neg. No.: L91-15679
LISAR NO.: EL-1994-00464
Photo Credit: KSC
Photo Date: 3/19/90
Location: KSC SAEF II
Subject: Postflight Detail of Upper Left of Tray H11

Figure 611 (Postflight). This photograph is of the upper left one-fourth of the tray. The tray flanges, the sensor holders, and the base mounting plate all have a brown stain. There is a brown stain on the upper right edge of the sensor surfaces. Surroundings are reflected in the mirrorlike surfaces of the detectors.

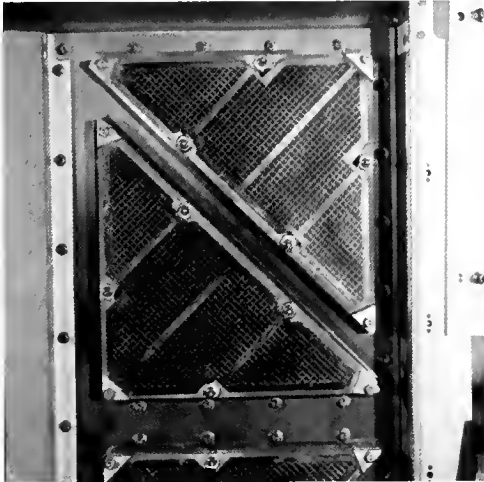
Figure 612
Photo No.: KSC-390C-2065.09
Dup. Neg. No.: L91-15680
LISAR NO.: EL-1994-00465
Photo Credit: KSC
Photo Date: 3/19/90
Location: KSC SAEF II
Subject: Postflight Detail of Upper Right of
Tray H11

Figure 612 (Postflight). This photograph is of the upper right one-fourth of the tray. The die-cast aluminum frames, fasteners, thermal isolation plate, and polished aluminum stop plate are moderately coated with a brown stain. The stain appears more concentrated in vicinities near adhesive bond joints.

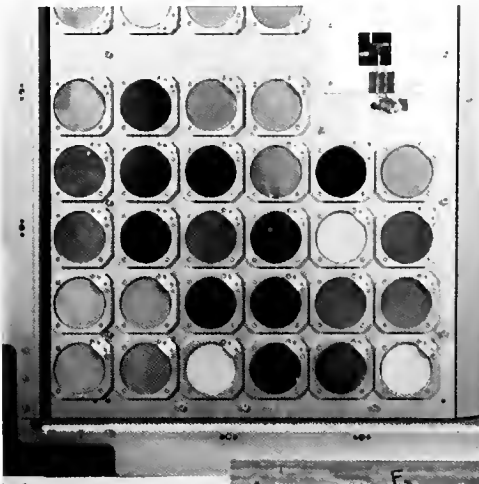
Figure 613
Photo No.: KSC-390C-2065.10
Dup. Neg. No.: L91-15681
LISAR NO.: EL-1994-00466
Photo Credit: KSC
Photo Date: 3/19/90
Location: KSC SAEF II
Subject: Postflight Detail of Lower Left of Tray H11

Figure 613 (Postflight). This photograph is of the lower left one-fourth of the tray. The tray flanges, the sensor holders, and the base mounting plate all have a brown stain. There is a brown stain on the upper right edge of the sensor surfaces. Surroundings are reflected in the mirrorlike surfaces of the detectors.

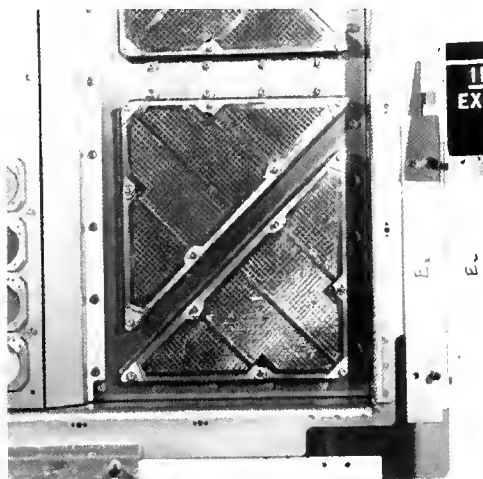
Figure 614 (Postflight). This photograph is of the lower right one-fourth of the tray. The die-cast aluminum frames, fasteners, thermal isolation plate, and polished aluminum stop plate seem to be moderately coated with a brown stain. The stain appears to be more concentrated in vicinities near adhesive bond joints. There are photographic light reflections in the foil sensor surfaces.

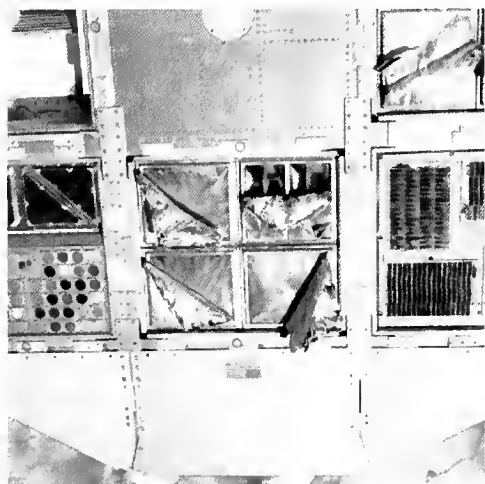
Figure 616
Photo No.: S32-75-067
Dup. Neg. No.: L90-10373
LISAR NO.: EL-1994-00676
Photo Credit: JSC
Photo Date: 1/12/90
Location: In Flight
Subject: In-Flight Survey of Tray H12

Figure 616 (In Flight). The multilayer thermal insulation blankets have extensive damage. The outside blanket surfaces that were originally white are now coated with a glossy dark brown stain. A light coating of the stain is on the tray flange adjacent to the American flag. Note the discolorations on the structure of the LDEF, tray flanges, and tray clamp white dots and the variation of discoloration with proximity to the thermal panel vents.

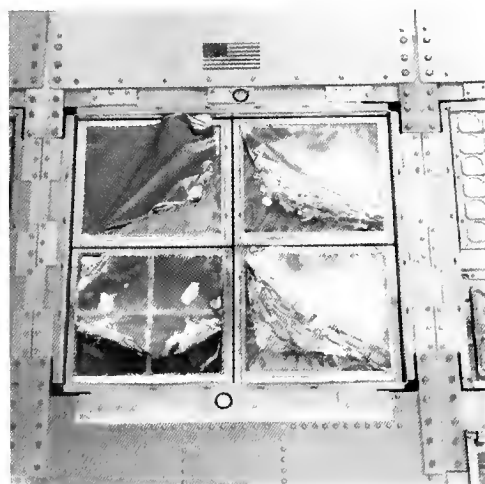
Figure 617
Photo No.: S32(S)-283
Dup. Neg. No.: L92-21190
LISAR NO.: EL-1994-00072
Photo Credit: JSC
Photo Date: 1/22/90
Location: Shuttle Cargo Bay at Dryden
Subject: Postflight Survey of Tray H12

Figure 617 (Postflight). This photograph of experiment M0001 was taken from the cargo bay access hatch of the orbiter during postlanding operations at the Dryden Flight Research Center. The photograph shows the extensive damage to the multilayer thermal blankets. The loose blankets appear to be more tightly rolled than in the in-flight photograph. The outside blanket surfaces that were originally painted white are now coated with a glossy dark brown stain.

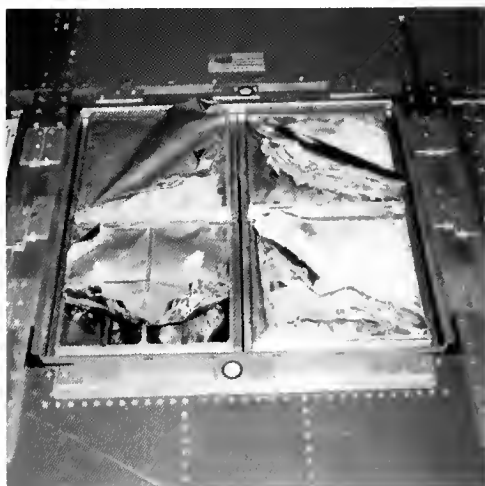
Figure 618
Photo No.: L90-1796
LISAR NO.: EL-1994-00380
Photo Credit: LaRC
Photo Date: 2/6/90
Location: KSC SAEF II
Subject: Postflight Survey of Tray H12

Figure 618 (Postflight). The postflight photograph shows the four experiment modules with multilayer thermal blankets that are severely degraded. Paint on the top layer, previously white, is now a glossy soft brown or tan. The thermal blankets apparently shrunk in flight, thus causing them to detach from the frame along two sides. The tape used to attach the blanket to the structure failed in tension across the width of the tape, thus leaving tape on both the frame and the top layer of the thermal blanket. The thermal blankets on the three large modules have curled to expose the top Lexan layer of the detector stack beneath. The curled thermal blankets that protected the four smaller modules in the lower left now expose the 5-mil aluminized Kapton film pressure covers beneath. The damaged thermal blankets on the right side of the photograph reveal representative cross sections of the multilayer thermal blankets.

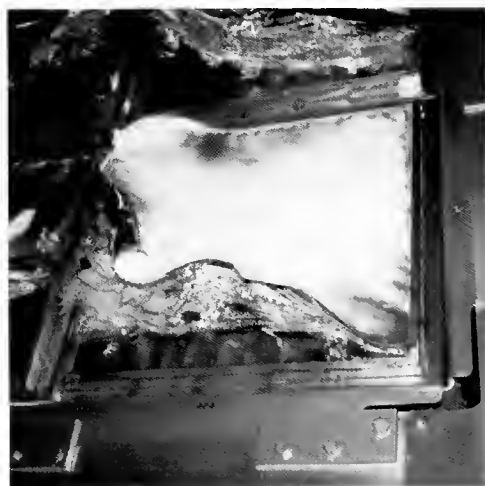
Figure 619
Photo No.: KSC-390C-828.05
Dup. Neg. No.: L91-15548
LISAR NO.: EL-1994-00166
Photo Credit: KSC
Photo Date: 2/6/90
Location: KSC SAEF II
Subject: Postflight Detail of Lower Right of
Tray H12

Figure 619 (Postflight). This photograph is of the lower right one-fourth of the tray. The discolored and damaged thermal blanket is shown. A representative cross section of the blanket is visible.

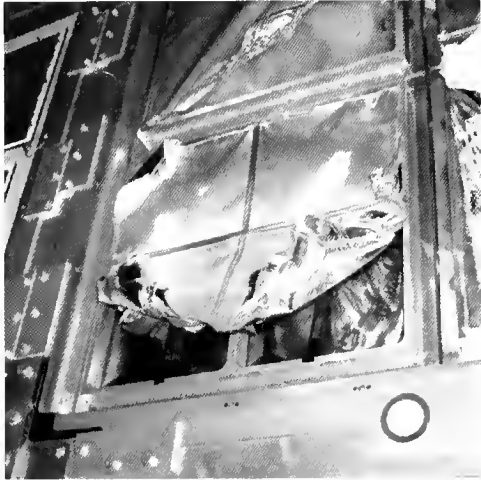
Figure 620
Photo No.: KSC-390C-828.06
Dup. Neg. No.: L91-15549
LISAR NO.: EL-1994-00167
Photo Credit: KSC
Photo Date: 2/6/90
Location: KSC SAEF II
Subject: Postflight Detail of Lower Left of Tray H12

Figure 620 (Postflight). This photograph is of the lower left one-fourth of the tray. The curled thermal blankets that protected the four smaller modules now expose the 5-mil aluminized Kapton film pressure covers beneath.

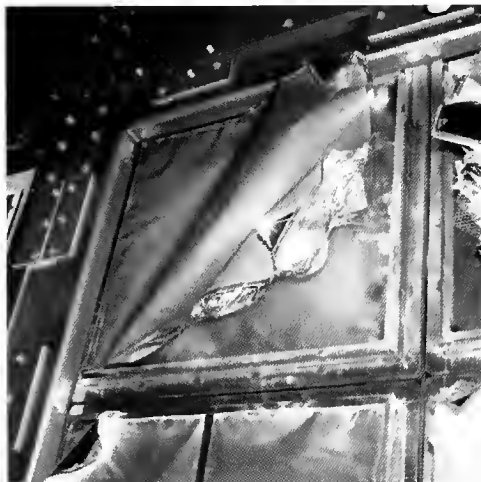
Figure 621
Photo No.: KSC-390C-828.07
Dup. Neg. No.: L91-15550
LISAR NO.: EL-1994-00168
Photo Credit: KSC
Photo Date: 2/6/90
Location: KSC SAEF II
Subject: Postflight Detail of Upper Left of Tray H12

Figure 621 (Postflight). This photograph is of the upper left one-fourth of the tray. The damaged thermal blanket has curled to expose the top Lexan layer of the detector stack beneath.

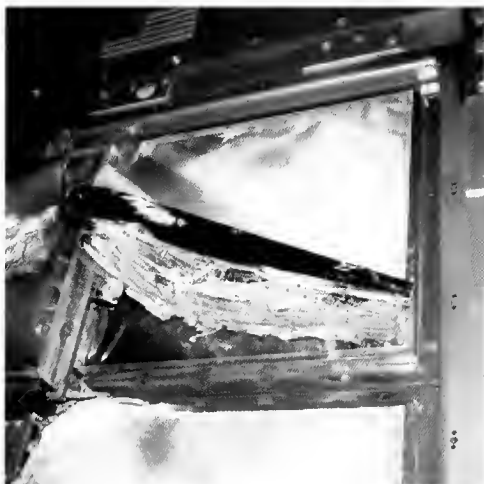
Figure 622
Photo No.: KSC-390C-828.08
Dup. Neg. No.: L91-15551
LISAR NO.: EL-1994-00169
Photo Credit: KSC
Photo Date: 2/6/90
Location: KSC SAEF II
Subject: Postflight Detail of Upper Right of
Tray H12

Figure 622 (Postflight). This photograph is of the upper right one-fourth of the tray. The discolored and damaged thermal blanket is shown. A representative cross section of the blanket is visible.

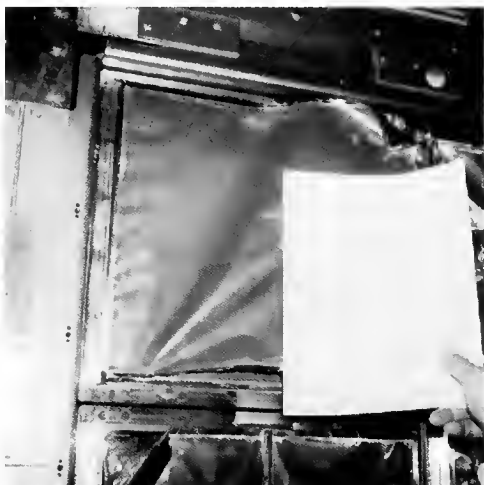
Figure 623
Photo No.: KSC-390C-829.02
Dup. Neg. No.: L91-15557
LISAR NO.: EL-1994-00283
Photo Credit: KSC
Photo Date: 2/6/90
Location: KSC SAEF II
Subject: Postflight Detail of Tray H12

Figure 623 (Postflight). This photograph shows a white card for comparison with the discolored thermal covers.

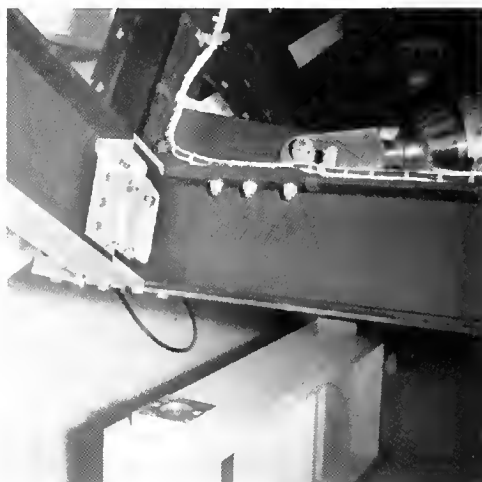
Figure 624 (Postflight). This photograph shows longeron A between rows 12 and 1 with the Earth-facing end to the left. The side of tray A12 was adjacent to this longeron. Little if any contamination on the longeron is visible. Note the discoloration on the intercostal to the left. The edge of the thermal panel location is marked by a line of concentrated brown discoloration. This discoloration was the effect of internal venting. The area covered by the tray flange contrasts with the unshielded area of the intercostal.

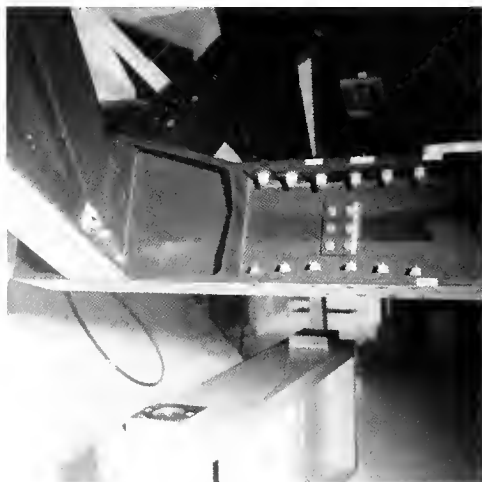
Figure 625 (Postflight). Longeron B between rows 1 and 2 with the Earth-facing end to the left is shown in this photograph. The side of tray A1 was adjacent to this longeron. The light area on the longeron is a reflection off the intercostal end fitting. There is a distinct pattern of discoloration on the side of the longeron. The discoloration on the intercostal is washed out by lighting.

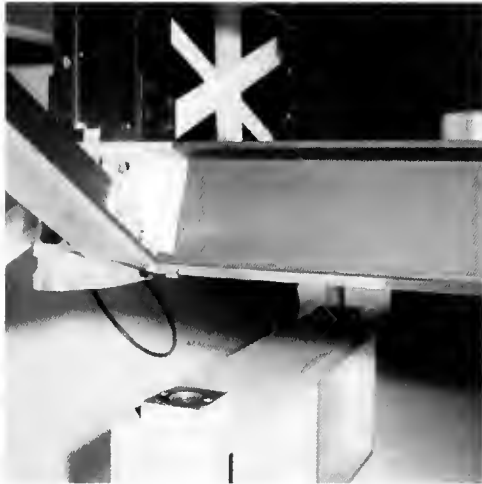
Figure 626 (Postflight). Longerons C between rows 2 and 3 with the Earth-facing end to the left is shown in this photograph. The side of tray A2 was adjacent to this longeron. The light area on the longeron is a reflection off the intercostal end fitting. There is no significant discoloration on the longeron or line of concentrated discoloration at the thermal panel edge location. The area covered by the tray flange contrasts with the unshielded area of the intercostal.

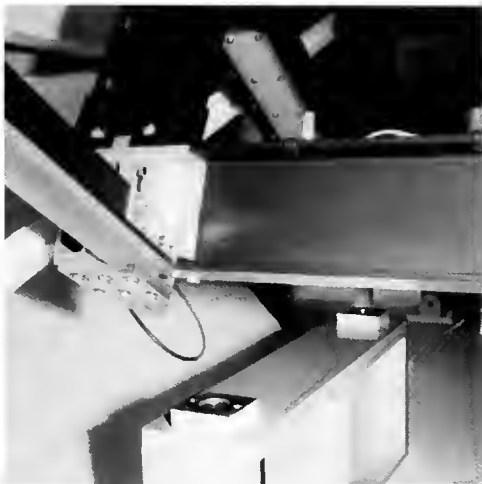
Figure 627 (Postflight). Longerons D between rows 3 and 4 with the Earth-facing end to the left is shown in this photograph. The side of tray A3 was adjacent to this longeron. The light area on the longeron is a reflection off the intercostal end fitting. There is no significant discoloration on the longeron or line of concentrated discoloration at the thermal panel edge location. The area covered by the tray flange contrasts with the unshielded area of the intercostal.

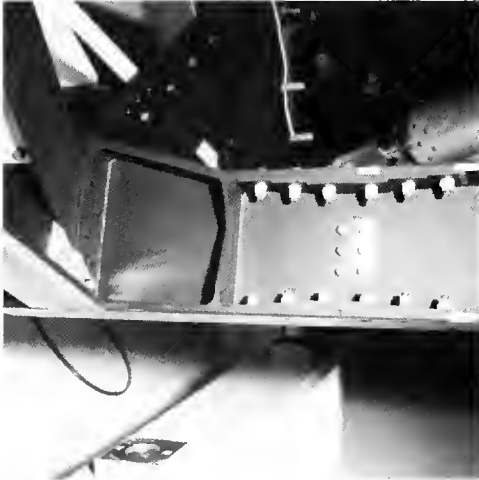
Figure 628 (Postflight). This photograph shows longeron E between rows 4 and 5 with the Earth-facing end to the left. The side of tray A4 was adjacent to this longeron. The considerable area of light on the longeron is a reflection off the intercostal end fitting. There is no significant discoloration on the longeron or line of concentrated discoloration at the thermal panel edge location. The area covered by the tray flange contrasts with the unshielded area of the intercostal.

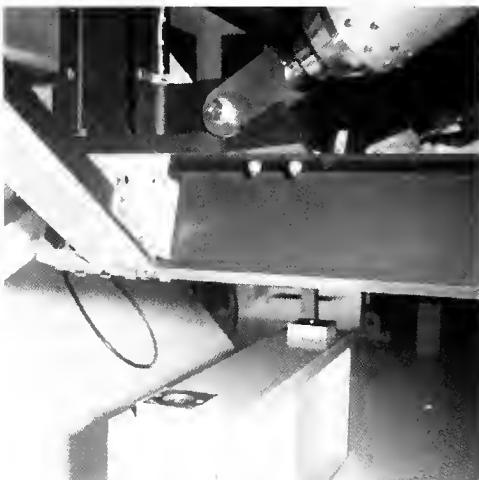
Figure 629 (Postflight). This photograph shows longeron F between rows 5 and 6 with the Earth-facing end to the left. The side of tray A5 was adjacent to this longeron. The light area on the longeron is a reflection off the intercostal end fitting. There is no significant discoloration on the longeron. There is no line of concentrated discoloration at the thermal panel edge location. The area covered by the tray flange contrasts with the unshielded area of the intercostal.

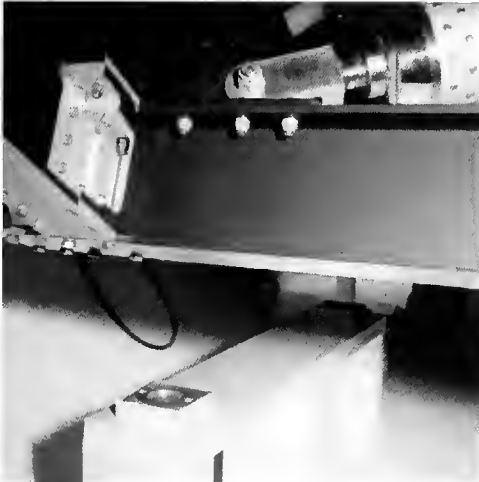
Figure 630 (Postflight). This photograph shows longeron G between rows 6 and 7 with the Earth-facing end to the left. The side of tray A6 was adjacent to this longeron. There is no visible discoloration on the longeron or line of concentrated discoloration at the thermal panel edge location. The area covered by the tray flange contrasts with the unshielded area of the intercostal.

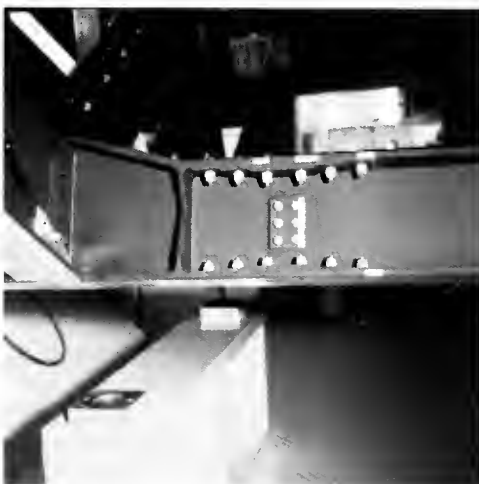
Figure 631 (Postflight). Longeron H between rows 7 and 8 with the Earth-facing end to the left is shown in this photograph. The side of tray A7 was adjacent to this longeron. The pattern of light on the longeron is a reflection off the intercostal end fitting. There is no significant discoloration on the longeron. The edge of the thermal panel location is marked by a line of concentrated brown discoloration. This was the effect of internal venting. The area covered by the tray flange contrasts with the unshielded area of the intercostal.

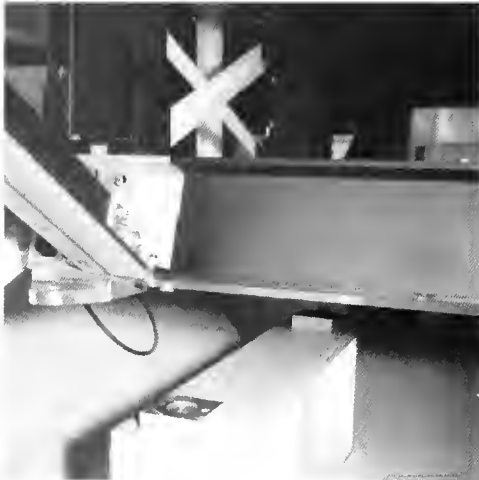
Figure 632 (Postflight). Longerons I between rows 8 and 9 with the Earth-facing end to the left is shown in this photograph. The side of tray A8 was adjacent to this longeron. There is a slight discoloration on the longeron. The edge of the thermal panel location is marked by a line of concentrated brown discoloration. This discoloration was the effect of internal venting. The area covered by the tray flange contrasts with the unshielded area of the intercostal.

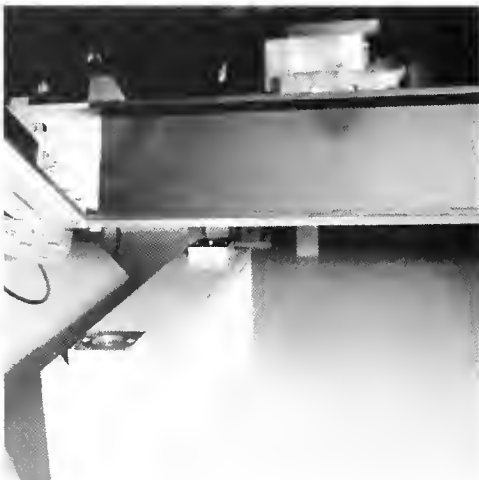
Figure 633 (Postflight). This photograph shows longeron J between rows 9 and 10 with the Earth-facing end to the left. The side of tray A9 was adjacent to this longeron. There is some discoloration on the longeron. The edge of the thermal panel location is marked by a line of concentrated brown discoloration. This discoloration was the effect of internal venting. The area covered by the tray flange contrasts with the unshielded area of the intercostal.

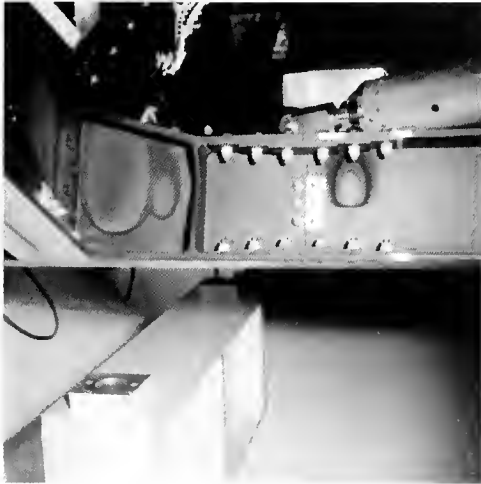
Figure 634 (Postflight). Longerons K between rows 10 and 11 with the Earth-facing end to the left is shown in this photograph. The side of tray A10 was adjacent to this longeron. There are areas of heavy discoloration on the longeron. This pattern of discoloration was the heaviest on longeron K. The edge of the thermal panel location is marked by a line of concentrated brown discoloration on the intercostal. This discoloration was the effect of internal venting. The area covered by the tray flange contrasts with the unshielded area of the intercostal.

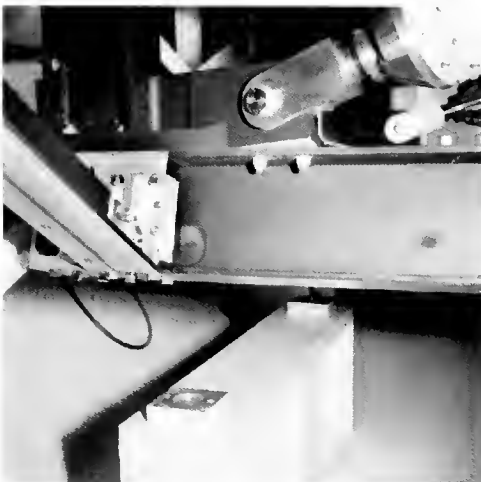
Figure 635 (Postflight). This photograph shows longeron L between rows 11 and 12 with the Earth-facing end to the left. The side of tray A11 was adjacent to this longeron. There are small areas of heavy discoloration on the longeron. The edge of the thermal panel location is marked by a line of concentrated brown discoloration on the intercostal. This discoloration was the effect of internal venting. The area covered by the tray flange contrasts with the unshielded area of the intercostal.

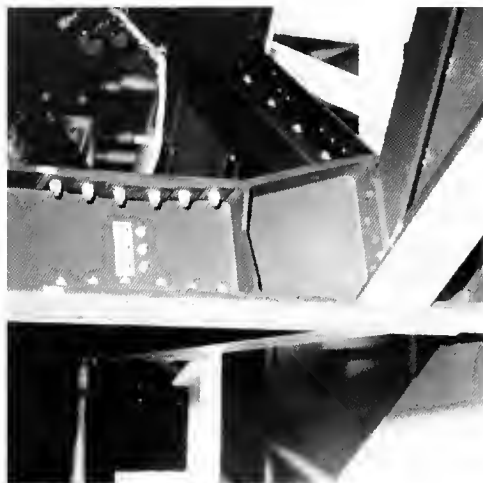
Figure 636 (Postflight). This photograph shows longeron B between rows 1 and 2 with the Earth-facing end to the right. The side of tray A2 was adjacent to this longeron. The pattern of light on the longeron is a reflection off the intercostal end fitting. There is no visible discoloration on the longeron or line of concentrated discoloration at the thermal panel edge location. The area covered by the tray flange contrasts with the unshielded area of the intercostal.

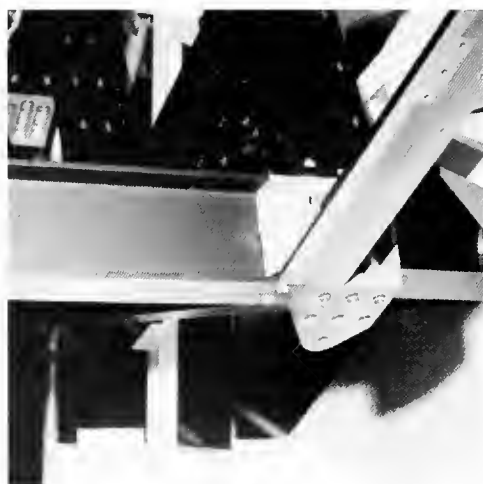
Figure 637 (Postflight). Longeron C between rows 2 and 3 with the Earth-facing end to the right is shown in this photograph. The side of tray A3 was adjacent to this longeron. The pattern of light on the longeron is a reflection off the intercostal end fitting. There is no visible discoloration on the longeron or line of concentrated discoloration at the thermal panel edge location. The area covered by the tray flange contrasts with the unshielded area of the intercostal and longeron.

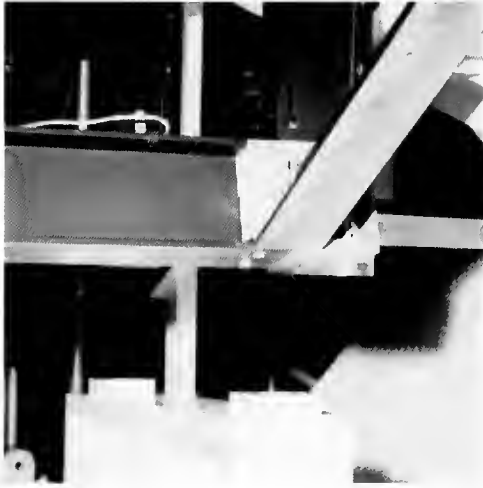
Figure 638 (Postflight). Longerons D between rows 3 and 4 with the Earth-facing end to the right is shown in this photograph. The side of tray A4 was adjacent to this longeron. There is no visible discoloration on the longeron. There is no line of concentrated discoloration at the thermal panel edge location. The area covered by the tray flange contrasts with the unshielded area of the intercostal.

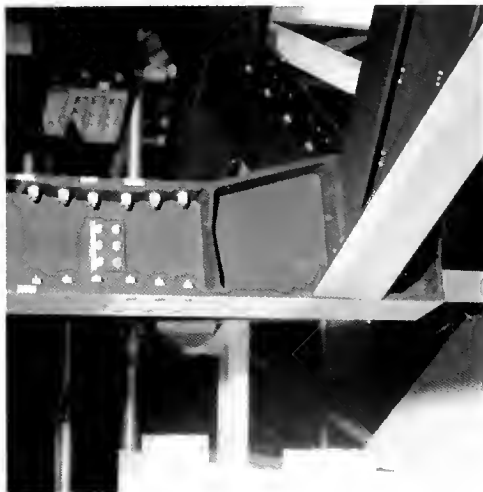
Figure 639 (Postflight). This photograph shows longeron E between rows 4 and 5 with the Earth-facing end to the right. The side of tray A5 was adjacent to this longeron. The pattern of light on the longeron is a reflection off the intercostal end fitting. There is a discoloration on the longeron. There is no line of concentrated discoloration at the thermal panel edge location. The area covered by the tray flange contrasts with the unshielded area of the intercostal.

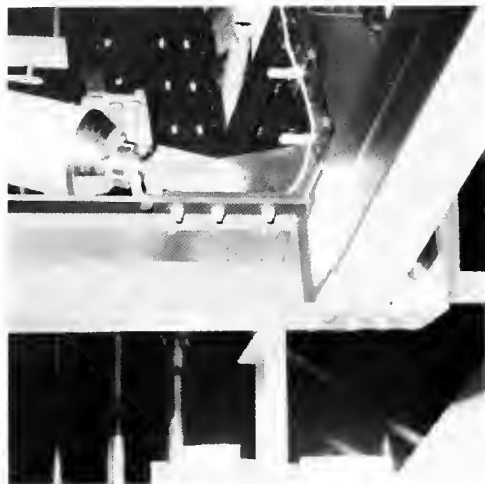
Figure 640 (Postflight). This photograph shows longeron F between rows 5 and 6 with the Earth-facing end to the right. The side of tray A6 was adjacent to this longeron. There is a heavy and distinct pattern of discoloration on the longeron. Note the distinct pattern of the bolts. There is no line of concentrated discoloration at the thermal panel edge location. The area covered by the tray flange contrasts with the unshielded area of the intercostal.

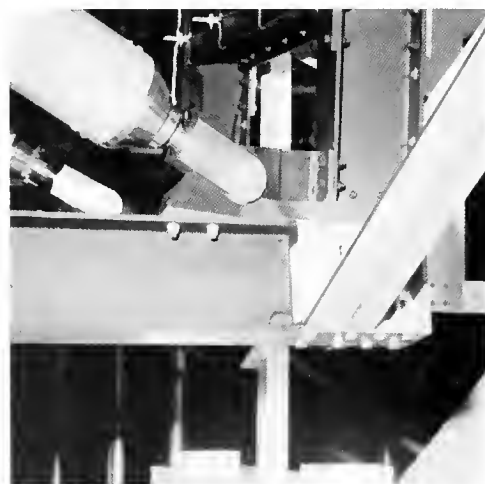
Figure 641 (Postflight). This photograph shows longeron G between rows 6 and 7 with the Earth-facing end to the right. The side of tray A7 was adjacent to this longeron. There is a small pattern of discoloration on the longeron and on the diagonal structural member fitting. There is a distinct line of concentrated discoloration at the thermal panel edge location. This discoloration was the effect of internal venting. The area covered by the tray flange contrasts with the unshielded area of the intercostal.

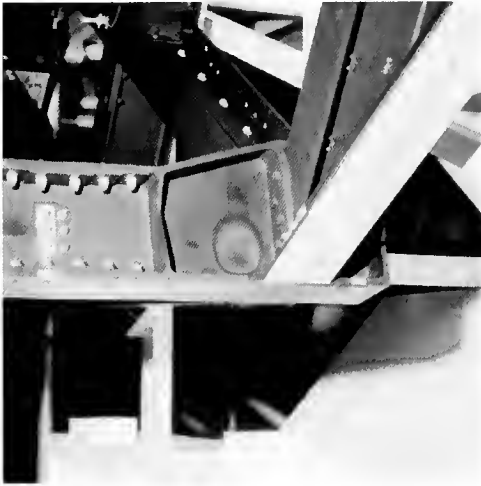
Figure 642 (Postflight). Longerons H between rows 7 and 8 with the Earth-facing end to the right is shown in this photograph. The side of tray A8 was adjacent to this longeron. There is a pattern of discoloration on the longeron. There is a distinct line of concentrated discoloration at the thermal panel edge location. The area covered by the tray flange contrasts with the unshielded area of the intercostal.

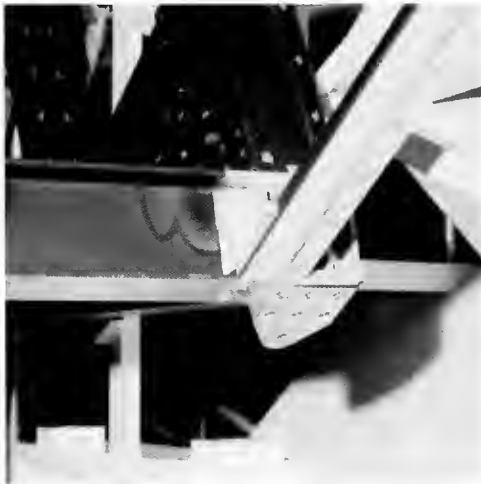
Figure 643 (Postflight). Longerons I between rows 8 and 9 with the Earth-facing end to the right is shown in this photograph. The side of tray A9 was adjacent to this longeron. There is a large pattern of discoloration on the longeron. There is a distinct line of concentrated discoloration at the thermal panel edge location. This discoloration was the effect of internal venting. The area covered by the tray flange contrasts with the unshielded area of the intercostal.

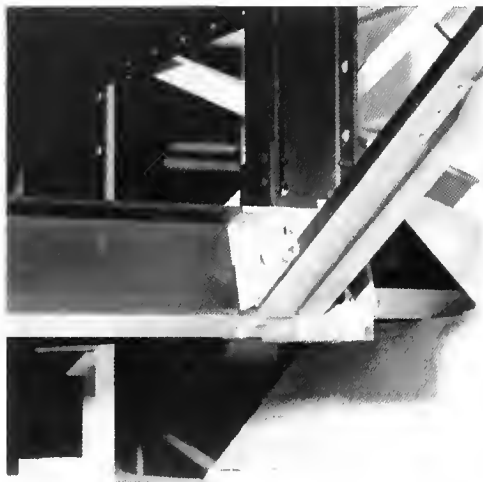
Figure 644 (Postflight). Longerons J between rows 9 and 10 with the Earth-facing end to the right is shown in this photograph. The side of tray A10 was adjacent to this longeron. There is little if any discoloration on the longeron. There is a distinct line of discoloration at the thermal panel edge location. The area covered by the tray flange contrasts with the unshielded area of the intercostal.

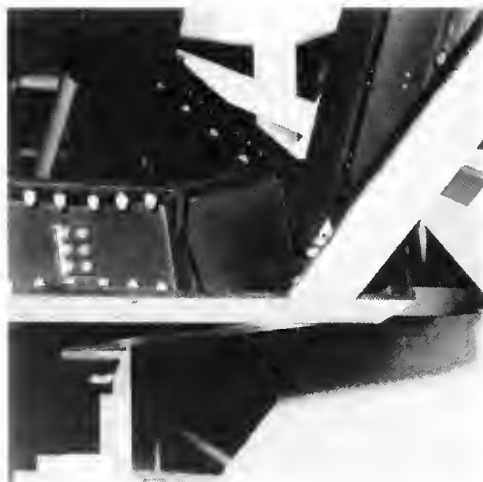
Figure 645 (Postflight). This photograph shows longeron K between rows 10 and 11 with the Earth-facing end to the right. The side of tray A11 was adjacent to this longeron. There is little if any discoloration on the longeron. There is a distinct line of discoloration at the thermal panel edge location. The area covered by the tray flange contrasts with the unshielded area of the intercostal.

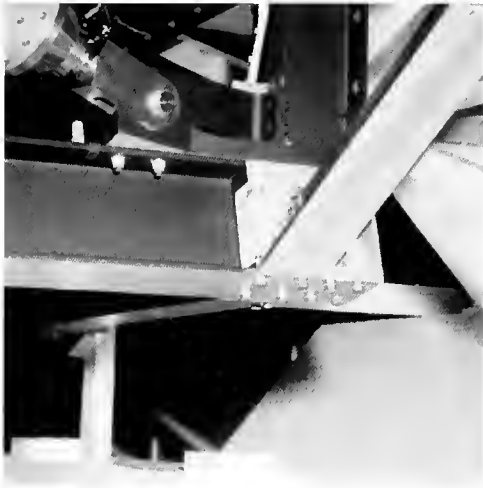
Figure 646 (Postflight). This photograph shows longeron L between rows 11 and 12 with the Earth-facing end to the right. The side of tray A12 was adjacent to this longeron. There is no discoloration on the longeron. There is no line of concentrated discoloration at the thermal panel edge location. The area covered by the tray flange contrasts with the unshielded area of the intercostal.

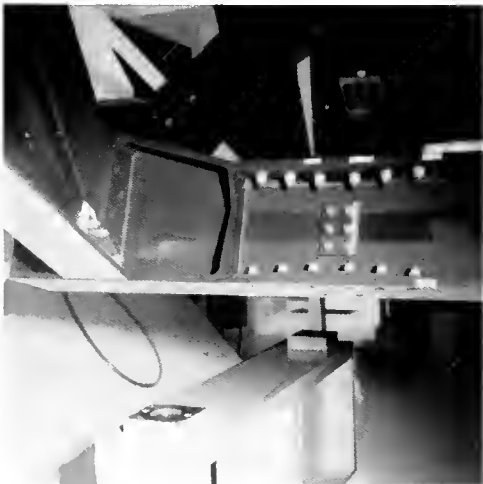
Figure 647 (Postflight). Tray A1 was adjacent to this part (left intercostal of bay A) of longeron B. Longeron B (Earth-facing end to left) was selected because of the distinct patterns on the longeron web. There is a significant and well-defined pattern of discoloration near the left intercostal.

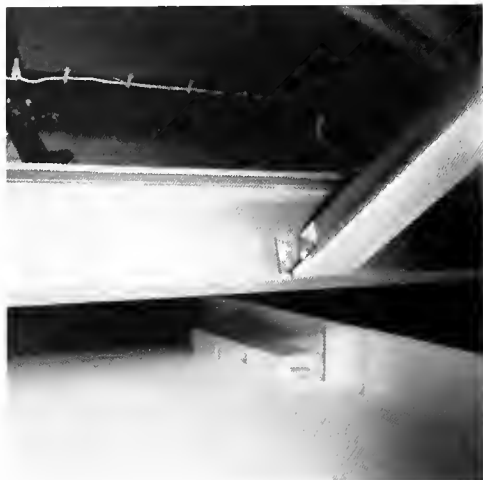
Figure 648 (Postflight). Tray A1 was adjacent to this part (right intercostal of bay A) of longeron B. The pattern fades near the center of the bay, but it gets darker near the right intercostal.

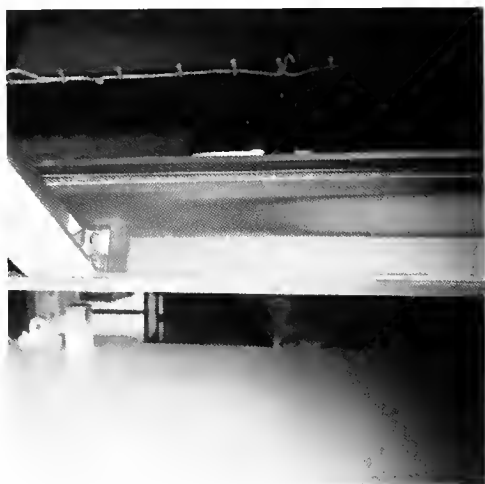
Figure 649 (Postflight). Tray B1 was adjacent to this part (left intercostal of bay B) of longeron B. There is a significant and well-defined pattern of discoloration with multiple shading near the left intercostal.

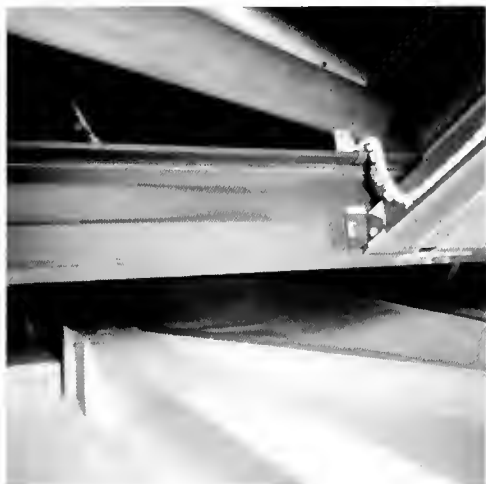
Figure 650 (Postflight). Tray B1 was adjacent to this part (right intercostal of bay B) of longeron B. There is a significant and well-defined pattern of discoloration with multiple shading near the right intercostal.

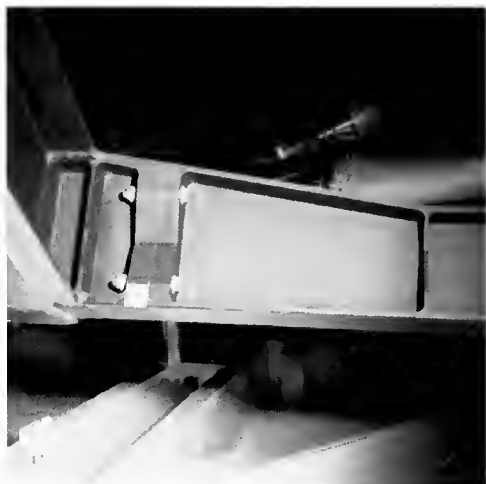
Figure 651 (Postflight). Tray D1 was adjacent to this part (center ring of bay D) of longeron B. There is a small faint pattern of discoloration on the longeron near the center ring.

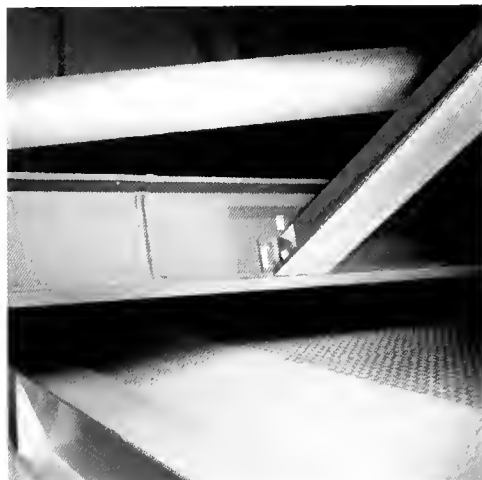
Figure 652 (Postflight). Tray D1 was adjacent to this part (right intercostal of bay D) of longeron B. There is a distinct pattern of discoloration near the right intercostal but none in the center.

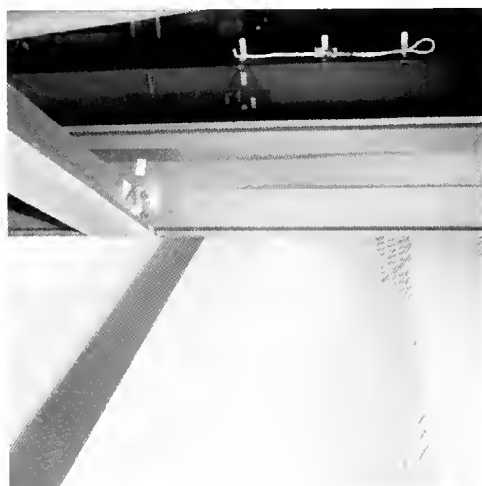
Figure 653
Photo No.: KSC-390C-2949.11
Dup. Neg. No.: L92-18266
LISAR NO.: EL-1994-00640
Photo Credit: KSC
Photo Date: 4/8/90
Location: SAEF II
Subject: Postflight Detail of Left Side of Bay E

Figure 653 (Postflight). Tray E1 was adjacent to this part (left intercostal of bay E) of longeron B. There is a significant and well defined pattern of discoloration with multiple shadings near the left intercostal.

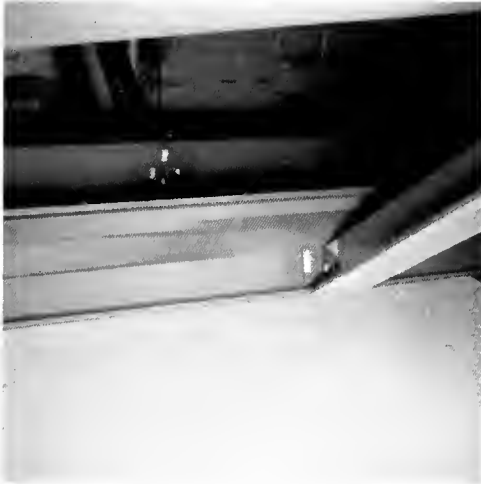
Figure 654 (Postflight). Tray E1 was adjacent to this part (right intercostal of bay E) of longeron B. There is a significant and well defined pattern of discoloration with multiple shadings near the right intercostal.

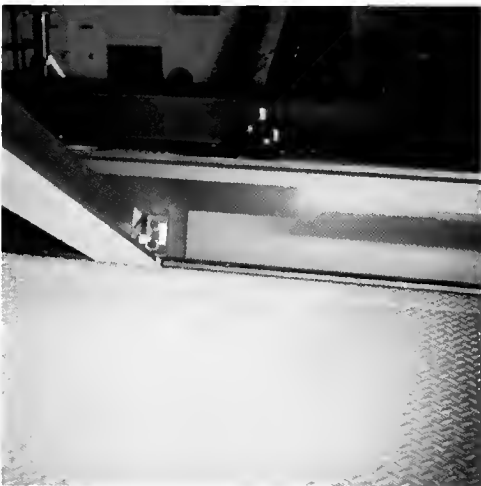
Figure 655 (Postflight). Tray F1 was adjacent to this part (left intercostal of bay F) of longeron B. There is a significant and well defined pattern of discoloration with multiple shadings near the left intercostal.

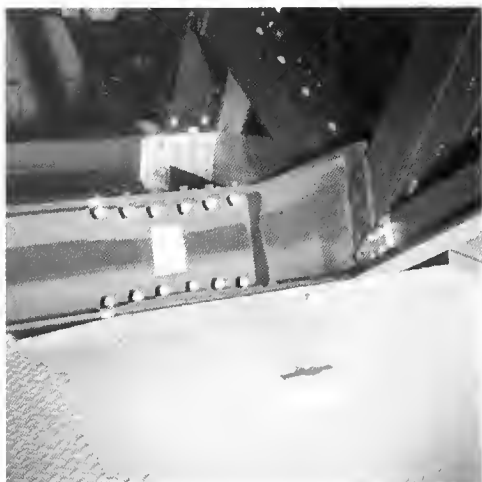
Figure 656 (Postflight). Tray F1 was adjacent to this (right intercostal of bay F) part of longeron B. There is a significant and well defined pattern of discoloration with multiple shadings near the right intercostal.

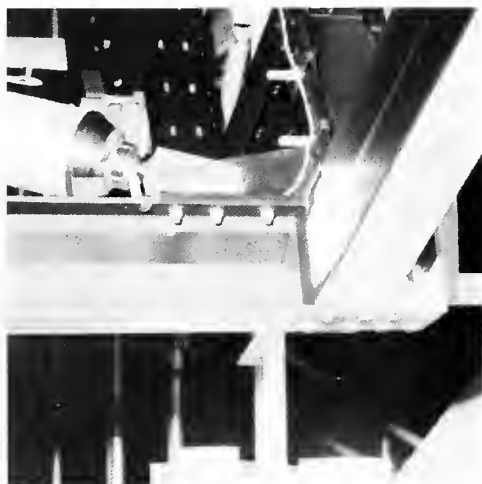
Figure 657 (Postflight). Tray A6 was adjacent to this part (right intercostal of bay A) of longeron F. The Earth-facing end of LDEF is to the right in this photograph, which shows longeron F between rows 5 and 6. There is a significant and well-defined pattern of discoloration near the right intercostal. Note the sharp patterns of the bolts and wiring clamp.

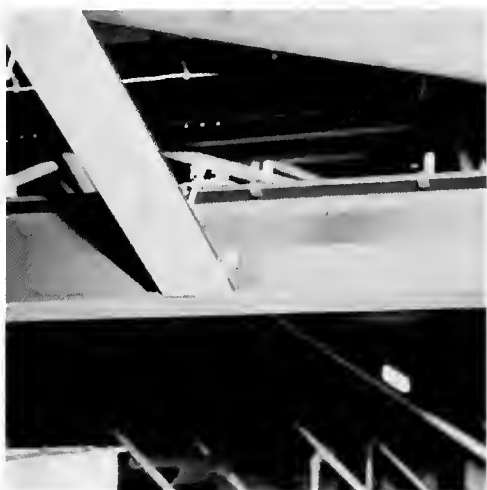
Figure 658 (Postflight). Tray A6 was adjacent to this part (left intercostal of bay A) of longeron F. There is a significant and well defined pattern of discoloration near the left intercostal. Note the wiring clamp patterns.

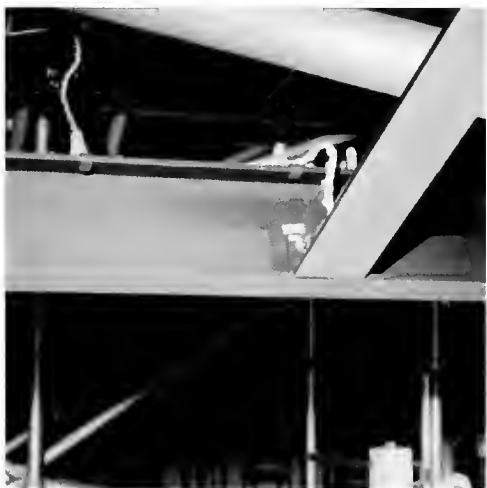
Figure 659 (Postflight). Tray B6 was adjacent to this part (right intercostal of bay B) of longeron F. There is a significant and well-defined pattern of discoloration near the right intercostal. Note the wiring clamp and wiring wrap patterns. The patterns fade near the center of the bay.

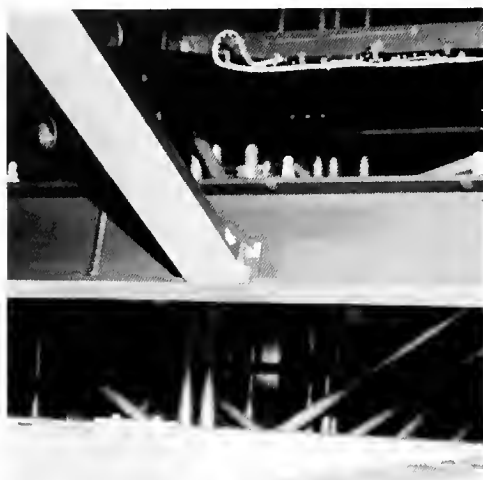
Figure 660 (Postflight). Tray B6 was adjacent to this part (left intercostal of bay B) of longeron F. There is a significant and well-defined pattern of discoloration near the left intercostal. Note the faint pattern of the wiring clamp. The pattern fades near the center of the bay.

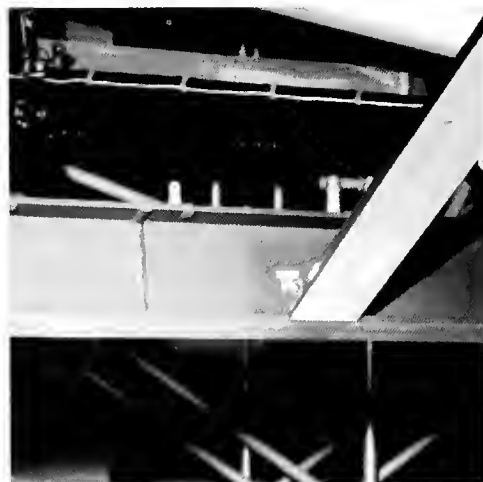
Figure 661 (Postflight). Tray C6 was adjacent to this part (right intercostal of bay C) of longeron F. There is a significant and well-defined pattern of discoloration with distinctly different shadings near the right intercostal. Note the sharp cutoff of the discoloration just to the left of the intercostal.

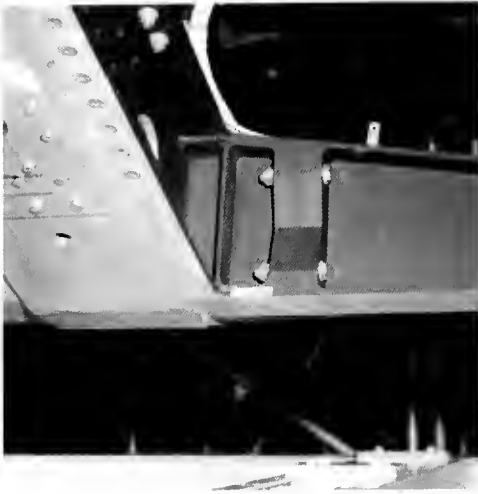
Figure 662 (Postflight). Tray C6 was adjacent to this part (center ring of bay C) of longeron F. There is a faint indication of a pattern of discoloration near the center ring.

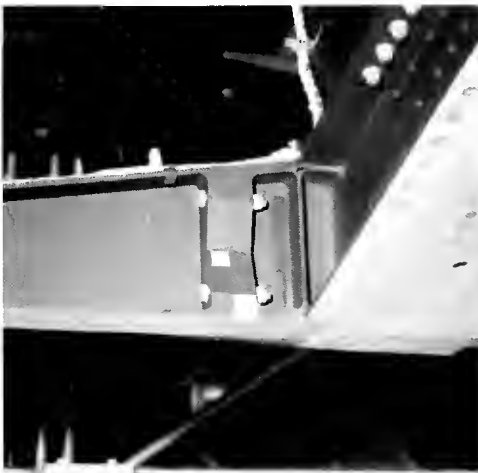
Figure 663 (Postflight). Tray D6 was adjacent to this (center ring of bay D) part of longeron F. There is a small pattern of discoloration near the center ring.

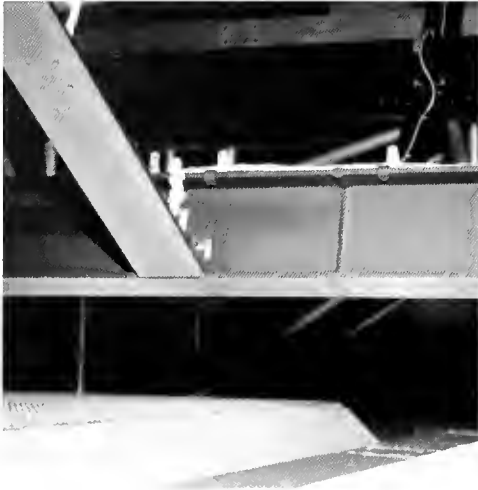
Figure 664 (Postflight). Tray D6 was adjacent to this part (left intercostal of bay D) of longeron F. There is a significant and well-defined pattern of discoloration near the left intercostal. Note the faint wire clamp pattern. The pattern fades near the center of the bay.

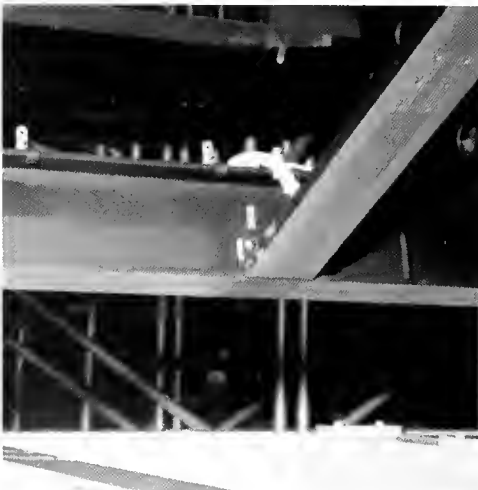
Figure 665 (Postflight). Tray E6 was adjacent to this part (right intercostal of bay E) of longeron F. There is a distinct and well-defined pattern of discoloration. Note the wire clamp patterns.

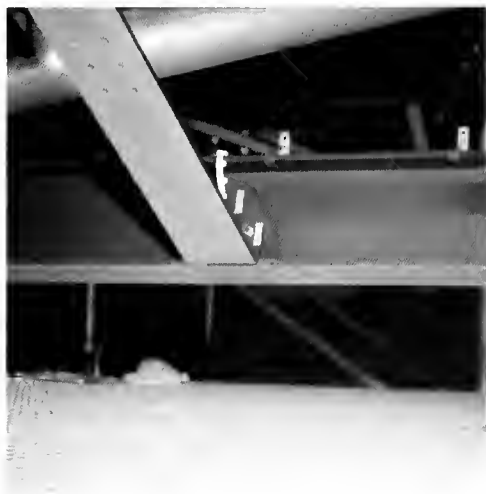
Figure 666 (Postflight). Tray E6 was adjacent to this part (left intercostal of bay E) of longeron F. There is a significant and well-defined pattern of discoloration.

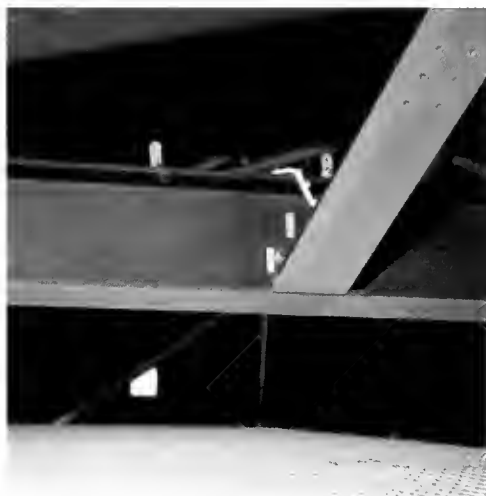
Figure 667 (Postflight). Tray F6 was adjacent to this part (right intercostal of bay F) of longeron F. There is a faint pattern of discoloration near the right intercostal. There is also a sharp cutoff of the discoloration just to the left of the intercostal.

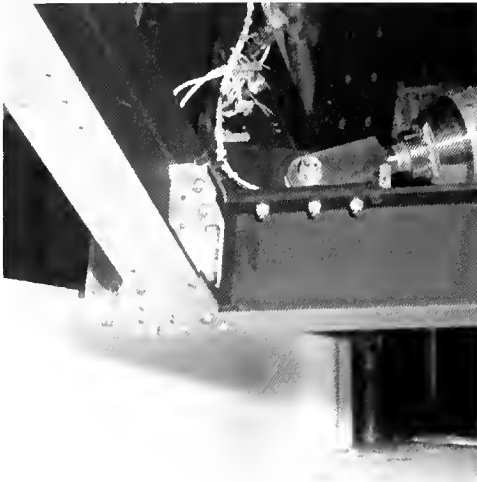
Figure 668 (Postflight). Tray F6 was adjacent to this part (left intercostal of bay F) of long-eron F. There is a small but distinct pattern of discoloration near the left intercostal.

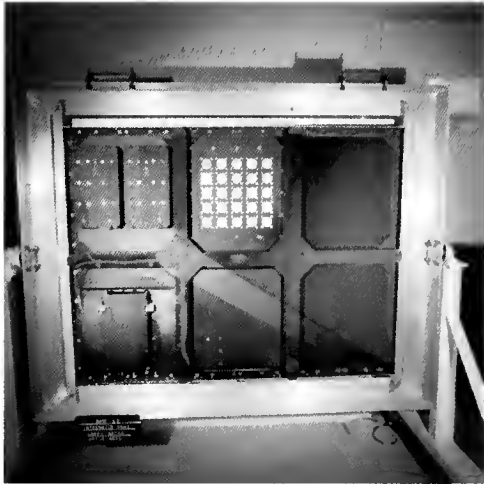
Figure 669
Photo No.: KSC-390C-1545.08
Dup. Neg. No.: L91-9080
LISAR NO.: EL-1994-00710
Photo Credit: KSC
Photo Date: 3/2/90
Location: KSC
Subject: Postflight View of Back of Tray C3

Figure 669 (Postflight). Note the extensive contamination and discoloration. There is the pattern of a diagonal structural member across the back of the tray. There is also a pattern where a wiring harness has been removed from the lower left tray members.

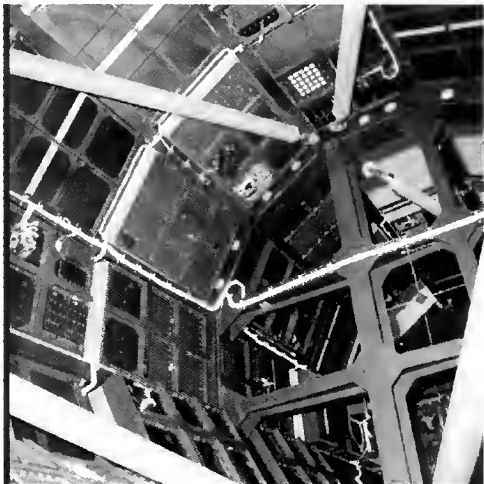
Figure 670
Photo No.: KSC-390C-1481.07
Dup. Neg. No.: L91-15630
LISAR NO.: EL-1994-00049
Photo Credit: KSC
Photo Date: 2/28/90
Location: SAEF II
Subject: Postflight View of LDEF Interior

Figure 670 (Postflight). The interior of the LDEF was essentially black to provide radiative coupling in thermal control of the facility. Note the pattern of discoloration on the back of tray B2 in the top left of the photograph.

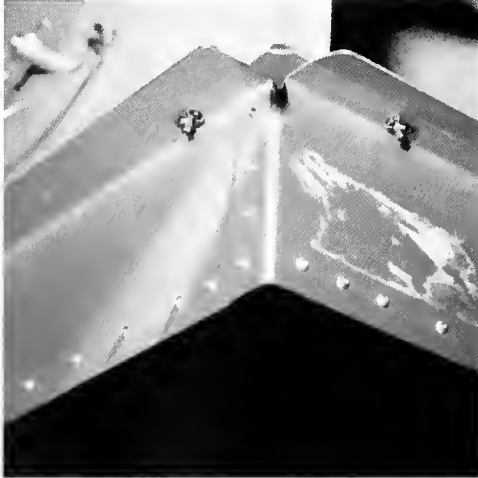
Figure 671 (Postflight). This photograph of tray F11 shows extensive discoloration and contamination. Note the discoloration below the rivet heads. It appears that during tray manufacture or integration, tape had been placed on the tray sidewall and the tray was improperly cleaned after the tape was removed.

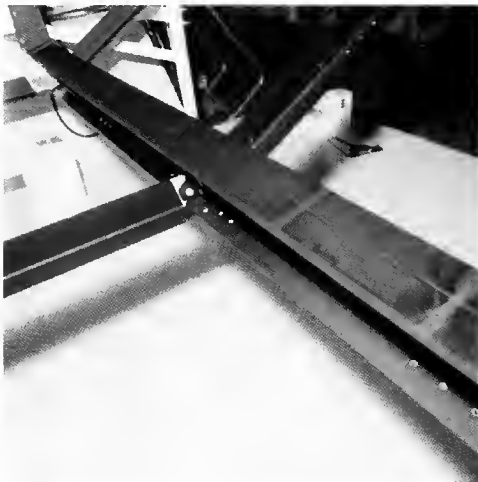
Figure 672 (Postflight). This photograph of the interior flange of the longeron D shows the discoloration pattern after the wiring harness and wire holding clips were removed.

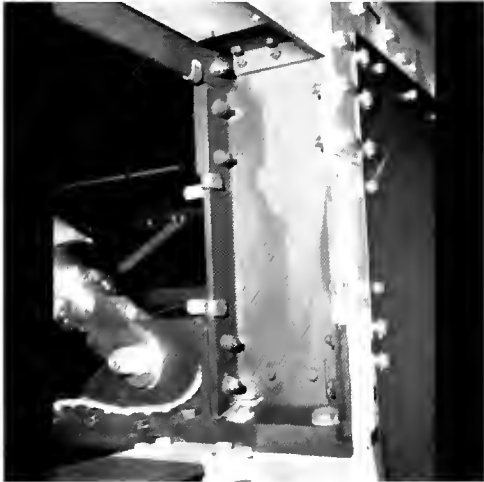
Figure 673
Photo No.: L90-01517
LISAR NO.: EL-1994-00054
Photo Credit: LaRC
Photo Date: 1990
Location: SAEF II
Subject: Postflight Detail of Structure Discoloration

Figure 673 (Postflight). This photograph is of the structural member adjacent to the end of longeron F (between rows 5 and 6) at the Earth-facing end of the LDEF. Note the extensive color and highly directional patterns of the bolts and nuts.

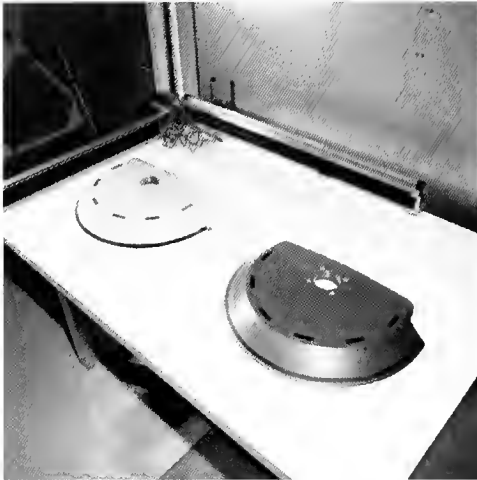
Figure 675
Photo No.: L90-01537
LISAR NO.: EL-1994-00055
Photo Credit: LaRC
Photo Date: 1990
Location: SAEF II
Subject: Postflight Detail of Scuff Plates

Figure 675 (Postflight). This set of trunnion scuff plates was removed from the LDEF after flight. The brighter scuff plate was on the leading side during flight, while the duller one was on the trailing side.
